RE: Site Inspection, Hecla Mining Company, Escalante Silver Mine, M/021/004, Iron County, Utah

Photographs of Waste Rock Pile, Hecla Mining Company, Escalante Silver Mine, M/021/004,
Iron County, Utah, February 27, 2002

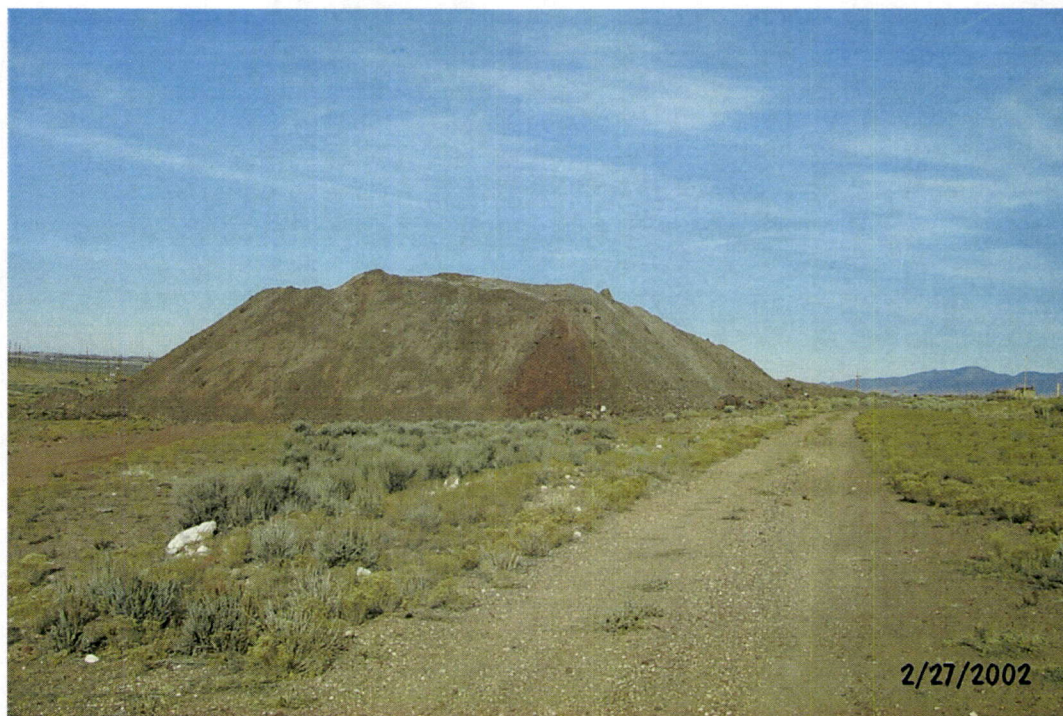
Photo 1.

Although this was my first time seeing the waste rock pile, it was clear the rest of the pile has not been graded, topsoiled, or revegetated. Most of the slopes, especially on the north and west sides, are nearly 1h:1v. I understood the operator was to have dug a trench from which to obtain soil and that part of the pile would be pushed into this trench. I found something of a trench on the north side of the pile (Photos 3 and 5), but it did not appear topsoil had been taken from this area. Also, I could not see that any of the waste rock material had been graded into the trench.

The waste rock pile still needs to be reclaimed.

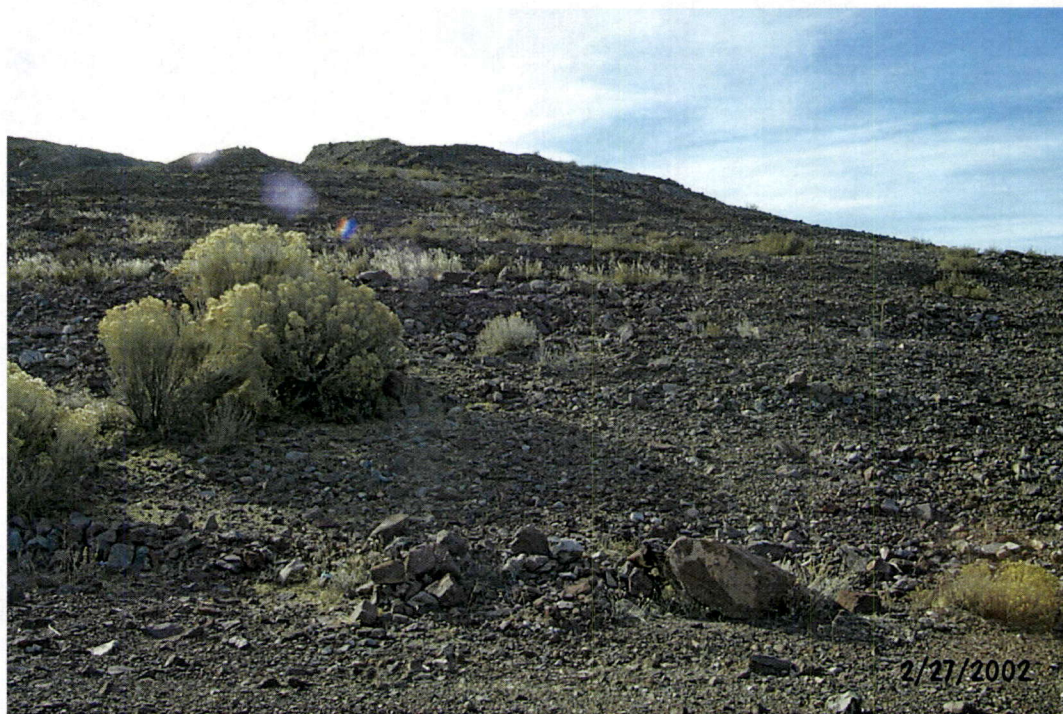
Photo 2.

The attached photographs show the condition of the waste rock pile. On the east side (Photo 2), there is an area that looks like it might have been graded and possibly had some soil applied at some time in the past, but the vegetation consists primarily of cheatgrass with some scattered rubber rabbitbrush.

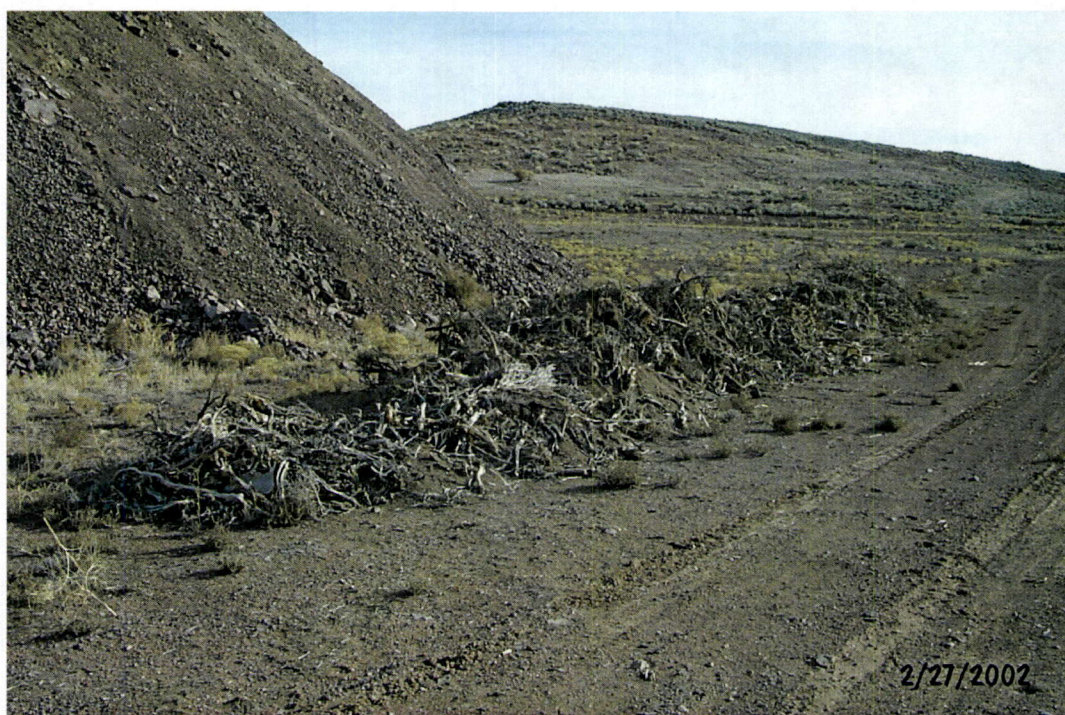
Photo 4.

On the northwest corner of the pile, there was a windrow of brush with some soil (Photo 4). I do not know the origin of this material, but it did not appear to have come from any kind of trench, and it had not been spread over the pile for reclamation.
